Research on Overheating Defects and Faults of Engine Piston Top

Rongrong SUN
Binzhou University, China

KEYWORDS -overheating, experimental method, piston, engine

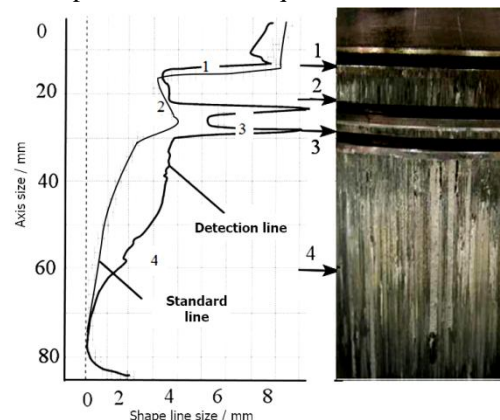
Fig.2 Detection results of shape line

profile, because the profile processing is based on the established procedures of CNC lathe, and the profile meets the standard. The detection diagram of the fault piston profile is shown in Fig. 2. As can be seen in Fig.2, significant wear occurs at positions 1 and 3, and severe scratches occur at the remaining two locations. From the whole contour diagram, the contour of the fault piston exists, and the contour of position 1 and 3 basically conforms to the standard trajectory. Some of the contours of position 1 and 3 exceed the standard trajectory because of the convex deformation caused by the extrusion deformation of the piston behind the viscous cylinder. The contours of position 2 and 4 are seriously depressed and deformed, all of which are caused by the serious wear and tear of the piston after the viscous cylinder. Caused by depressions of varying degrees. In summary, the processing profile of the fault piston is within the trajectory of the standard profile, so the profile of the fault piston meets the requirements.

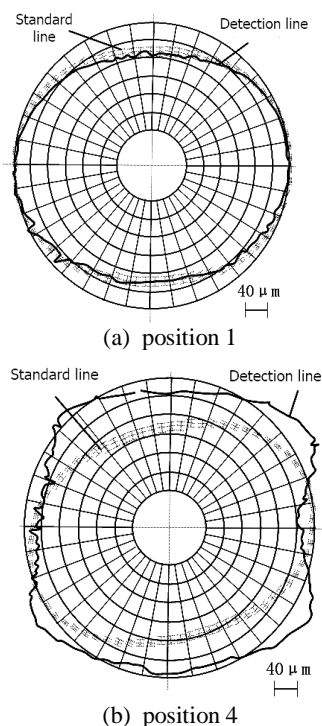
Fig.3 Test results of ellipticity

obtained as shown in Fig.3. In Fig.3, it can be seen that there is no viscous cylinder in position 1, and the piston damage is small. The ellipticity line of piston in this position basically coincides with the standard ellipticity line and meets the standard value. The ellipticity distortion of position 4 is serious and the deformation is obvious, which proves that the position bears much heat and load and is prone to wear and tear, which is consistent with the measurement results of profile. The ellipticity test results show that the melting phenomenon of the piston top surface has nothing to do with the quality of the piston machined and the load-bearing state of the piston during working.

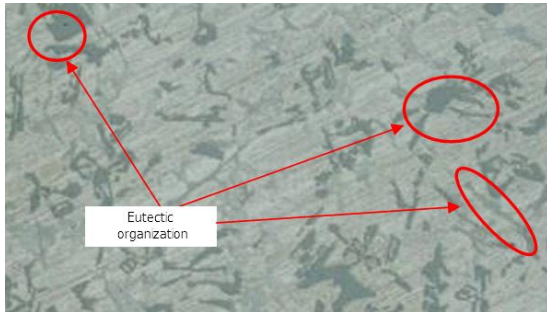
Fig.4 Metallographic examination results

As can be seen from Fig.4, this material belongs to eutectic structure. Eutectic silicon is distributed in the matrix of α -Al in granule or rod shape. It also has a large number of metallic compound phases, such as Mg, Fe, Gu, etc. The black eutectic silicon and the strip primary silicon have no segregation and are evenly distributed among the aluminum metals. Compared with the standard metallography, the particle sizes of the eutectic silicon and the strip primary silicon are in line with the standards and no microstructure abnormality is found.

The testing surface of metallographic sample was ground and polished again. The content of alloy elements was detected by spectroscopic analyzer. The results are shown in Table 1. As can be seen from Table 1, the alloy elements in the fused top piston are still within the standard range, and there is no serious segregation, which is consistent with the results in Fig.4.
