Prevention of Safety Accidents Caused by Structural Defects in Concrete Pump Car Booms

ABSTRACT : Concrete pump cars are indispensable in modern construction due to their ability to efficiently pour concrete into required locations. However, structural failures in boom components have caused several catastrophic accidents, resulting in fatalities and equipment damage. This study analyzes the causes of such failures, with a focus on the second-stage boom, which experiences the highest stress during operation. Finite Element Analysis (FEA) reveals that the second-stage boom has a maximum stress of 895.39 MPa, with a critically low safety margin of 0.04. The study proposes design enhancements such as increased material thickness and steel plate reinforcements. These measures aim to improve structural robustness and reduce the risk of failure, ensuring safer construction environments.

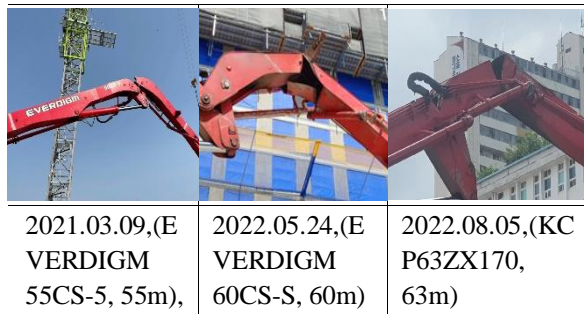
Three major boom failure cases from 2021–2022 were investigated, involving equipment with boom lengths of 55–63 meters. Common failure points were identified as the second boom section, which exhibited structural vulnerabilities.

Fig. 1. Accident status during concrete pouring

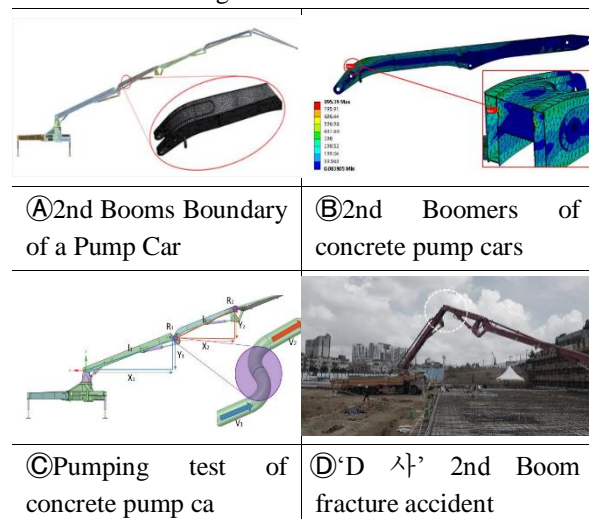
To analyze the structural weaknesses of the concrete pump car boom, finite element analysis was utilized. The results showed that the second-stage boom experiences the highest stress, and the low margin of safety (M.S.) in this area was identified as a major cause of boom failure. According to the finite element model analysis, the second-stage boom was found to exceed the maximum stress of the fifth-stage boom by approximately seven times, clearly indicating the need for structural reinforcement in this area during the design and manufacturing stages. The fatigue load on the second-stage boom is exacerbated by repeated vibrations and shock, making additional reinforcement and increased stiffness essential. These structural defects were identified as the primary cause of boom failure.

This study re-evaluated the structural safety of the pump car boom by considering fatigue loads caused by repeated vibrations during the pouring process, based on dynamic analyses presented in previous studies. The finite element model analysis confirmed that the second-stage boom is the most vulnerable part of the structure. The results indicated that the thickness of the second-stage boom components needs to be increased and additional reinforcement plates should be added at the upper part, as shown in Fig. 3(B). Furthermore, additional reinforcement for pump cars currently used in construction sites is also recommended. Additionally, as concrete is transported through the pumping pipe, impact loads are applied to the boom in the direction shown in Fig. 2(A). This phenomenon occurs due to periodic swinging of the boom during the pouring process, proportional to the inlet and outlet speeds. Fatigue stresses on the boom, analyzed through vibration and dynamic analysis, showed the highest fatigue stress occurring in the second-stage boom, as summarized in Table 2. Therefore, additional reinforcement and increased component stiffness for the second-stage boom are essential.

Fig. 2 Stress distribution of boom

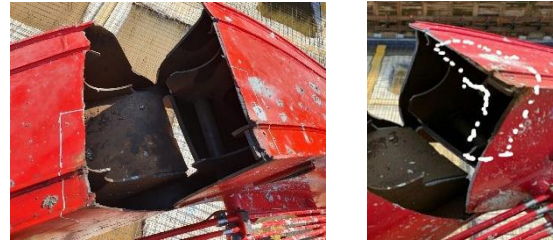
As pump car boom lengths and equipment sizes increase, the weight of the equipment rises, sometimes leading to reduced plate thickness to lighten the load. This compromises safety, especially as inappropriate adjustments are made to meet the 50-ton weight limit under road traffic laws. Such actions can lead to accidents. For example, cracks and corrosion were observed in the second boom, as shown in Fig3, highlighting the structural vulnerabilities.

Fig. 3. A sectional photograph of the pump car boom breakage of company D社 (death 2).
