Study on the LandCover Classification using UAV Imagery

ABSTRACT : *The study was carried out using the UAV for analyzing the characteristics of debris in order to present the methodology to estimate the quantitative amount of debris caught in small river facilities. A total of six small rivers that maintained the form of a natural river were selected for collecting UAV images, and the grouping of each target in the image was carried out using the object-based classification method, and based on the object-based classification result of the UAV images, the land cover classification for the status of factors causing the generation of debris for six target sections was carried out by applying the screen digitizing method. In addition, in order to verify the accuracy of the classification result, the error matrix was performed, securing the reliability of the result. The accuracy analysis result showed that for all six target sections, the overall accuracy was 93.95% and the Kappa coefficient was 0.93, showing an excellent result.*

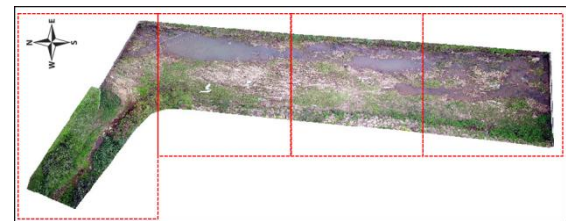
Figure.1 UAV images for six basins

compactness. Fig. 1 shows the UAV images for the six basins, and Fig. 2 shows the object-based classification result of the representative sections among the six basins.

Six rivers were classified into four sections using the UAV images and the object classification suitable for each image was undertaken by adjusting the scale, shape and
