Punching Shear Behavior of a Glass Fibers Bubble Deck Slab Subjected to Fire and Cooled by Water

Muntadher Kadhim Al-Fwadhil¹, Waleed A. Waryosh¹

¹*Civil Engineering Department, college of Engineering, Mustansiriyah University, Baghdad, Iraq*

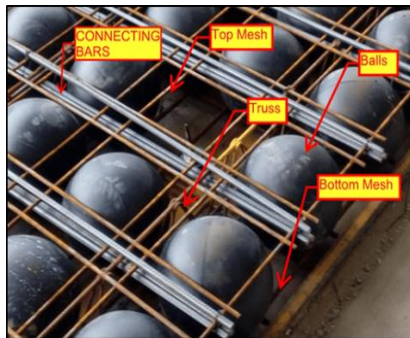
Fig. 1 Demonstrates the RC Bubble Slab System

column slab connections [5]. Fig.1 indicates a "RC" bubble slab system.

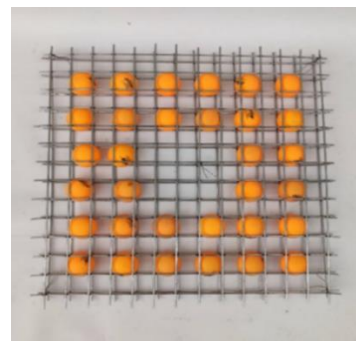
Fig. 2 Steel Reinforcement Mesh with Bubbles

Fifteen RC bubble slabs have been cast in the Structural Engineering Laboratory of College of Engineering at Mustansiriyah University in Baghdad. The examined slabs in this research were all square in shape and modeled as 1/5 of BD230 that mention in (Bubble Deck Span Guide) [9], with dimensions of (500x500) mm and 50 mm thickness and concrete cover was 10 mm. They were supported around their four edges using steel frame and loaded centrally with a square-sectioned steel cube of (40x40x40) mm. Bubble diameter was (30) mm with a spacing between bubbles (40) mm center to center and the reinforcement in both bottom and top layer is $\phi 3 @ 20$ mm (wire mesh). As shown in fig. 2.

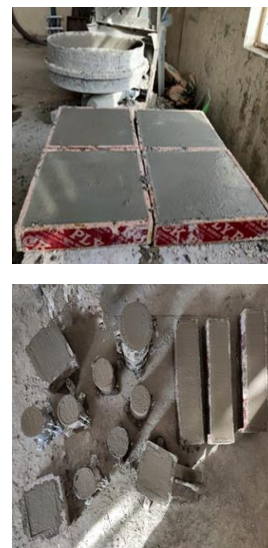
Fig. 3 Bubbled Reinforced Concrete Slabs and control specimens Casting

After that all specimens were casted and curing in the Structural Engineering Laboratory at College of Engineering in Mustansiriyah University. Fig. 3 shows the casted slabs and control specimens.

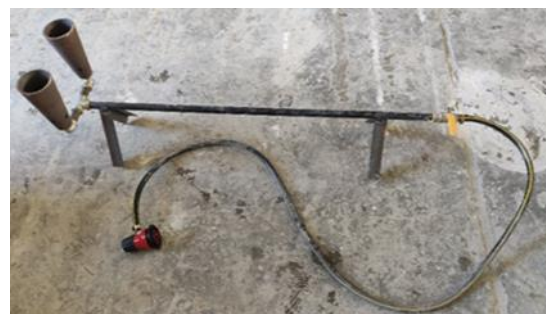
Fig. 4 The Burner

The bubble RC slab specimens were exposed to fire flame by the burners represented in Fig. 4. The fire flame is subjected to tension side of slabs, the distance between slab and fire flame is 20 cm. A steel fire chamber was used to present the true state of burning room; the frame was sealed on all sides with one opening as depicted on the Fig. 5.

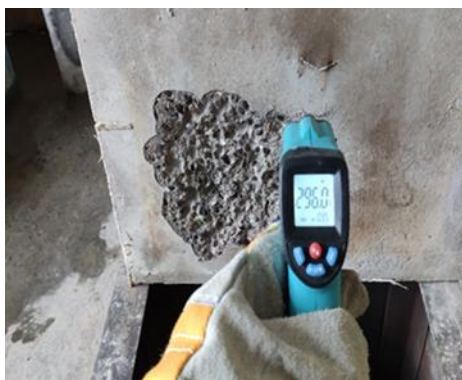
Fig. 6 Infrared Thermometer

An infrared thermometer with a temperature range of (-32 to 550) °C was used to calculate fire intensity on slab's bottom face. The temperature measuring unit is depicted in Fig. 6.

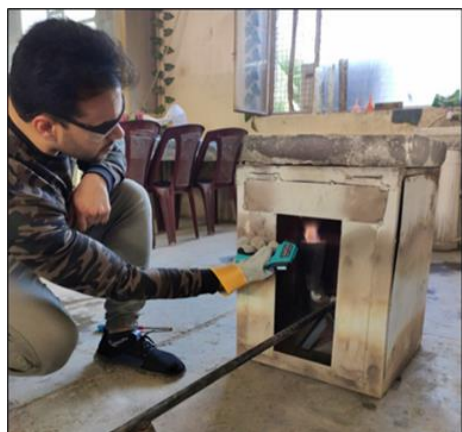
Fig. 7 Taking Average Temperature for Concrete

The specimens were burnt at a temperature of 300 °C for 30 minutes, with the face exposed to fire being tested every 5 minutes to determine the temperature of concrete and to guarantee that it stayed within the 300 °C cap as shown in Fig. 7. The average temperature on the other face was also measured to determine how heat is transmitted through the concrete.

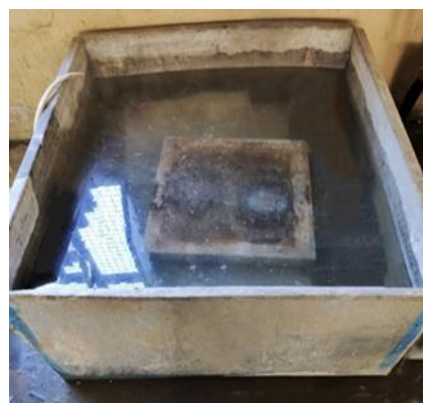
Fig. 8 Quenching Slab in Water

After burning stage of specimens is finished, it is moved to cooling stage, which is in four forms. The first method is to leave the specimens to cool down at room temperature, the second method is to immerse it in water for 10 minutes as in Fig. (8), and the third and fourth methods are to spray the specimens with water for 5 and 10 minutes, respectively as in Fig. (9). The immersion was performed in one of the basins, which is the same temperature as tap water used in spraying which is about 15 °C.

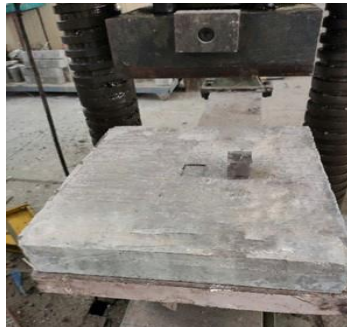
Fig. 10 Punching Shear Test of Specimens

As seen in Fig. 10, a solid square steel cube with dimensions (40X40X40) mm was positioned over the middle of the slab to provide concentrated load.

The slab was labeled carefully and then they were placed on a rigid support with a clear span of (0.5x0.5) m. The point load was applied at the center of the slab and a 0.01mm dial gauge was positioned directly under the middle of each slab. to measure the central deflection. All slabs were tested using a hydraulic universal testing machine of the type (EPP300MFL system) with a capacity of (3000 kN) available in the structural Laboratory in Civil Engineering Department, College of Engineering, Mustansiriyah University. The load was applied progressively in 2.5 kN increments.

Throughout the test, the number of loads and subsequent deflections are recorded, providing an accurate reflection of the slab's structural behavior. Both the load at the first crack and the ultimate punching shear load, as well as their subsequent deflections at the slab center, were detected and recorded.

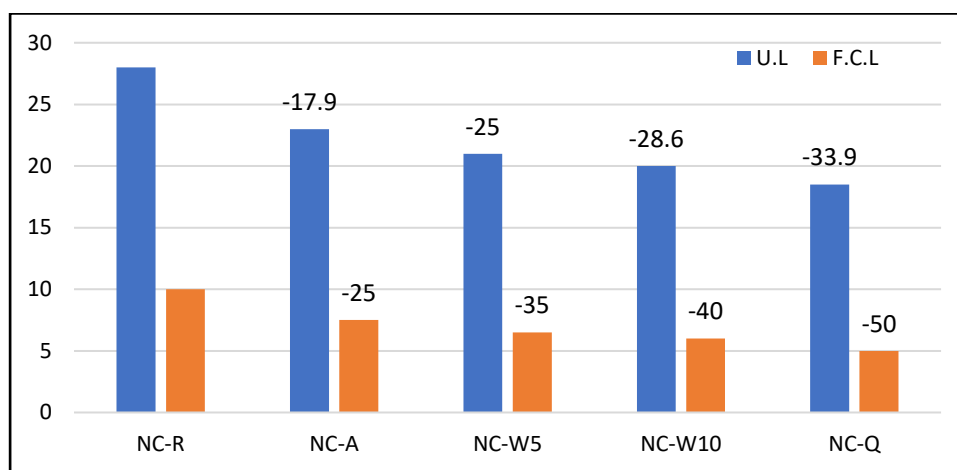
Fig. 11 Ultimate Load Results for Normal Strength Concrete

By moving to water cooling method spraying water on tension face for 5 and 10 min bring the load of specimen NSC-W5 and NSC-W10 down to (21 and 20) kN which is lower than that in control slab at (25 and 28.6) % and first crack appears at (6.5 and 6) kN which is less than the reference at (35 and 40) % and the reason of that decrease in ultimate load and first crack load is the fast and deeper deterioration caused by water and the effect of sudden cooling is show clearly in the last cooling method which is quenching the burned slab into water tank for 10 min and that made the ultimate load of NSC-Q decrease to (33.9) % of the ultimate load for reference slab at (18.5) kN and the first crack is (50) % from first crack load of the reference slab at (5) kN. First crack load varies from (27 to 35.71) % from the ultimate load of each specimen. The results in our study are close to what was observed by Botte and Caspeepe [14] in their research where quenching the specimens after heating results in the highest possible strength loss compared to spraying water and cooled the specimens gradually and that loss could reach 38% for 350 C° of heating. Annerel [15] and Bingöl et al. [16] showed the same results and this reduction is mainly attributed to the formation of microcracks caused by high thermal stress. Table 2 and Fig. 11 show the results of this group.

The tests show that the ultimate punching shear load for specimen NSC-R is (28) kN and the first crack appears at (10) kN which is (35.71 %) of the

ultimate load. After burn other slabs NSC-A the one which cooled with air failed at (23) kN which is (17.9) % of the ultimate load for reference slab because of the heat effect on tension face of the concrete slab and the first crack appear at (7.5) kN which is lower than that in reference slab by (25) % and for the same reason. The results are comparable to those of Al-Gasham [13]. The cement paste expands when heated, but from 300°C, a contraction occurs, associated with water loss. At this stage, aggregates continue to expand, and the resulting internal stresses can lead to loss of strength, cracking and flaking.

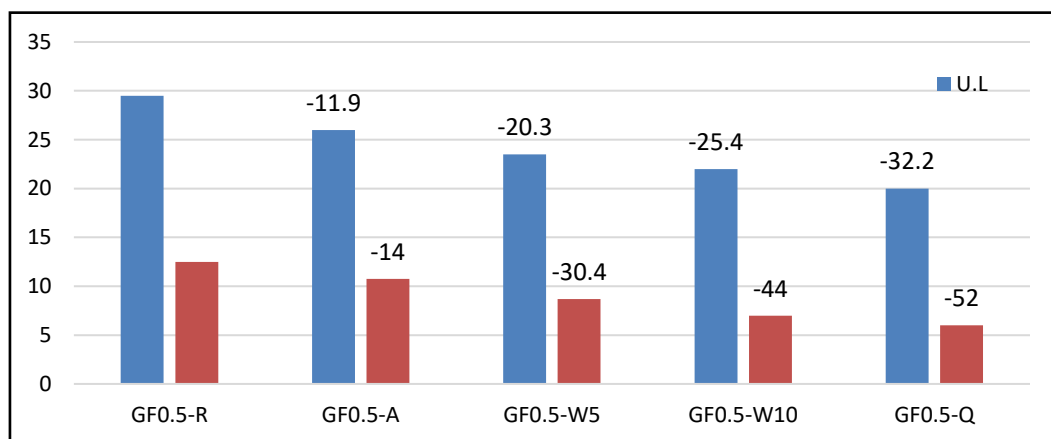
Fig. 12 Ultimate Load results for 0.5% Glass Fiber Concrete

rise in ultimate shear force capacity by (5) % comparing to normal strength concrete specimens. Additionally, the fibers act as a barrier to microcracks in concrete, which explains why the first crack load increases to reach (42.3) % of ultimate load in GF0.5-R but that's increase evanesce by using water to cool the specimens because adding glass fiber to concrete increase the porosity of concrete making water penetrates slab surface deeper than other slabs causing more deterioration. Additionally, the fibers help reduces spalling in concrete by creating channels for trapped moisture to escape after they are burned at a temperature of 170 °C. The fig.12 Illustrates the numbers graphically.

By advancing to the water-cooling method, spraying water on tension face for 5 and 10 min bring the ultimate load of GF0.5-W5 and GF0.5-W10 down to (23.5 and 22) kN which is lower than that in control slab GF0.5-R at (-20.3 and -25.4) % and first crack show at (8.7 and 7) kN which is less than the

The influence of water cooling is obvious in the final cooling technique which is quenching the burned slab into water for 10 min and that made the ultimate load of GF0.5-Q decrease to (-32.2) % of the reference slab GF0.5-R at (20) kN and the first crack is (-52) % from first crack load of the reference slab at (6) kN. The results in details as in Table 3.

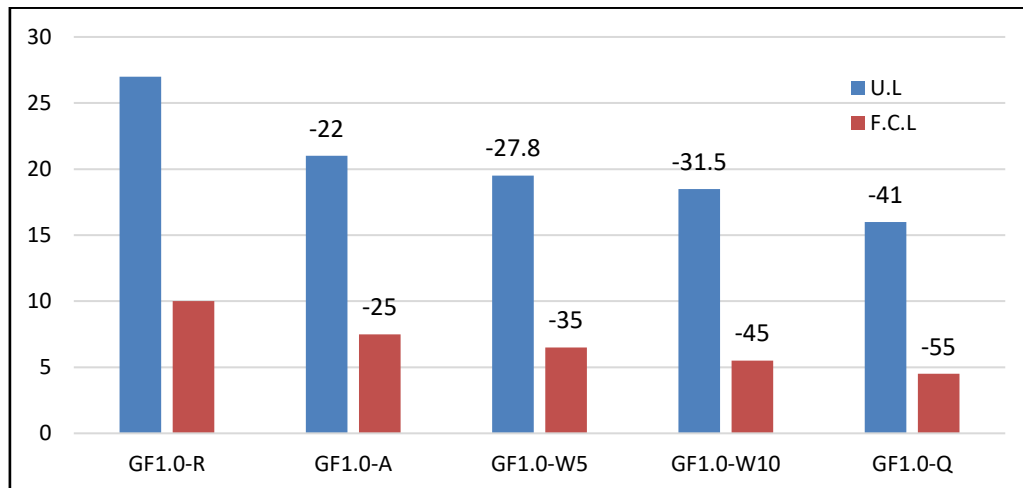
Fig. 13 Ultimate Load results for 1.0% Glass Fiber Concrete

Fig.13 show the variation in ultimate punching shear load in different cooling method.

min bring the ultimate load of GF1.0-W5 and GF1.0-W10 down to (19.5 and 18.5) kN which is lower than that in control slab GF1.0-R at (-27.8 and -31.5) % and first crack show at (6.5 and 5.5) kN which is less than the reference slab first crack at (-35 and -45) %. Quenching the burned slab into water for 10 min made the ultimate load of GF1.0-Q decrease to (-41) % of the reference slab at (16) kN and the first crack is (-55) % from first crack load of the reference slab at (4.6) kN. The results in details as in Table 4.

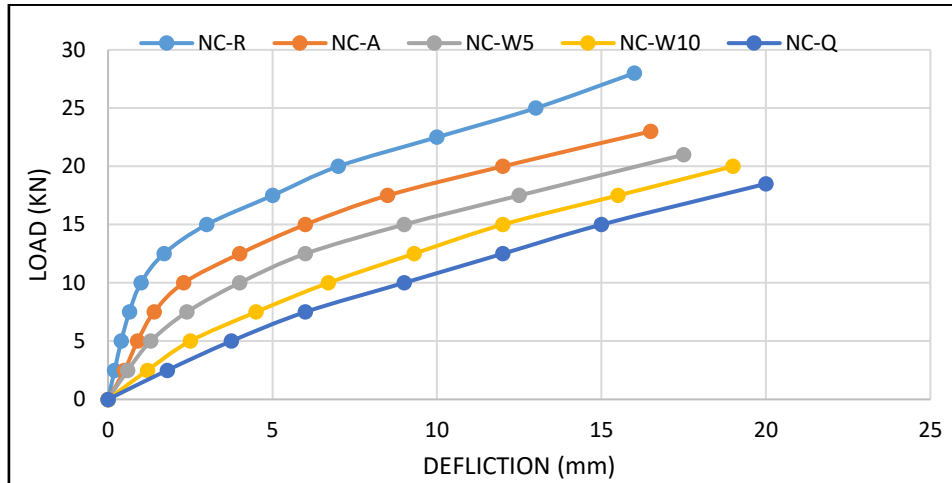
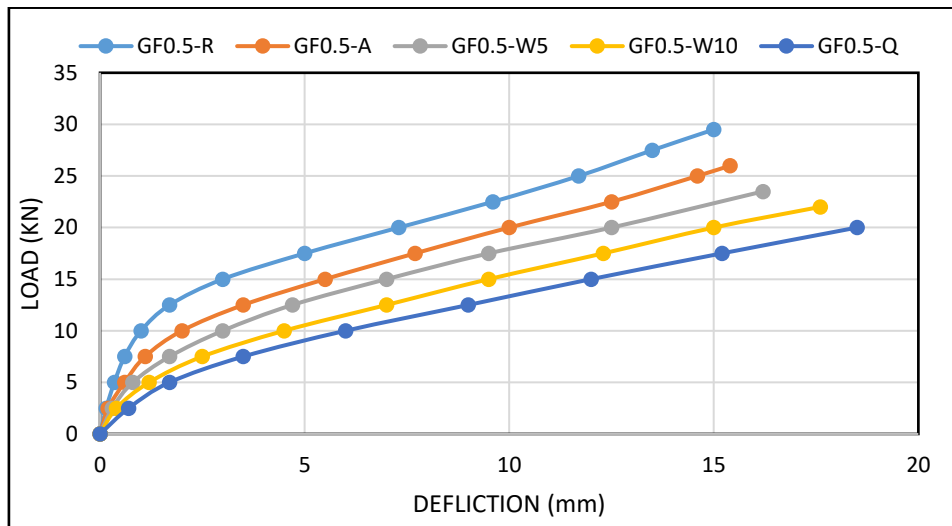
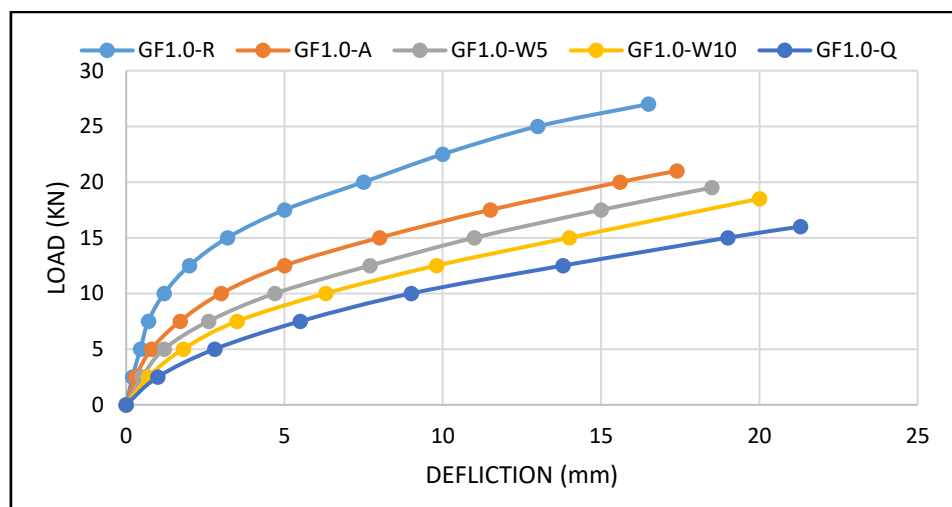
Fig. 14 Load-Deflection Curve

The deflection was measured at the center of slabs using a (0.01mm) dial gage with a load increment of 2.5 kN, and readings for these gages were recorded for each load increment. When a reinforced concrete slab is gradually loaded, the deflection increases linearly in an elastic manner. Once cracks begin to form, the slab's deflection increases at a faster rate. After the slab develops cracks, the load-deflection curve is nearly linear until the flexural reinforcement begins to yield, at which point the deflection continues to increase without an appreciable increase in load. Fig. 14 illustrate the load-deflection relationship for all specimens.

Fig. 14 illustrate the load-deflection relationship for all specimens. Table 5, 6 and 7 show Deflection's value.

(a) Load-Deflection Curves of Normal Strength Concrete Group

(b) Load-Deflection Curves Of (0.5 %) Glass Fiber Concrete Group

(c) Load-Deflection Curves Of (1.0 %) Glass Fiber Concrete Group

The reference specimen GF0.5-R exhibits greater resistance to deflection in both the first crack load and ultimate load tests than the NSC-R specimen. Even after burning, the resultant deflection is still less than that of normal concrete specimens, despite the fact that the fibers melt during the early stages of fire exposure. However, this decreases spalling rate in the concrete cover, making the slabs stronger.

Increased glass fiber content to 1% reduces the overall mechanical properties of concrete, including deflection. Even when not exposed to fire, reference specimen GF1.0-R exhibits greater deflection than NC-R, but fire has a massive impact on other specimens. Water cooling degrades the concrete structure more than air cooling, particularly the quenching approach, where the large porosity of the concrete structure resulted in a significant loss of stiffness.

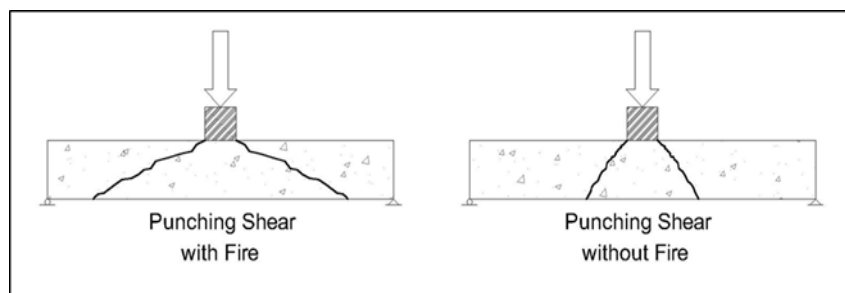
Fig. 15 The Impact of Fire on punching shear of Simply Supported Reinforced Concrete Slab.

Fig. 15 indicates the punching shear behavior associated to simply supported reinforced concrete slabs which are exposed to fire from beneath. The slabs' ends can rotate freely, also the slab can elongate freely (thermally un-restrained). Glassfibers contains straight bars which are

positioned close to slab's bottom. As the slab's underside is exposed to fire, bottom will be expanding more than top, the subsequent curvature makes the slab deflecting downwards. In the case when the reinforcement's strength decreases less than that needed for supporting slabs and any superposed load, the punching or flexural and punching failure is going to occur [13].

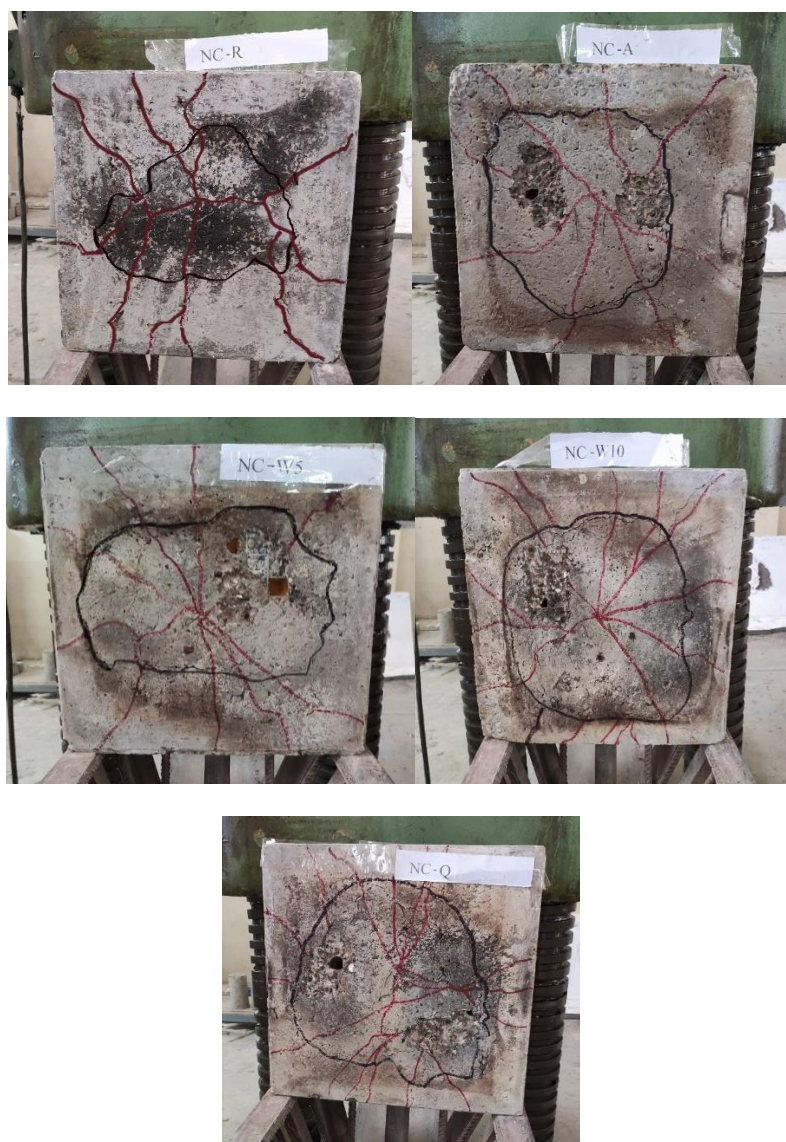
Fig. 16 crack pattern and punching perimeters of normal strength concrete

The difference in crack pattern between Glass fibers bubble slabs and normal strength concrete slabs was clearly shown due to the nature

of the two materials, with glass fiber specimens being tougher as shown in fig. 16, 17 and 18.

Punching zone was measured using Auto CAD by exporting a clear straight image to the program and draw over the punching area and using the command Area to calculate the actual area. the punching zone perimeter give an indicate of specimen strength at punching shear test and that is

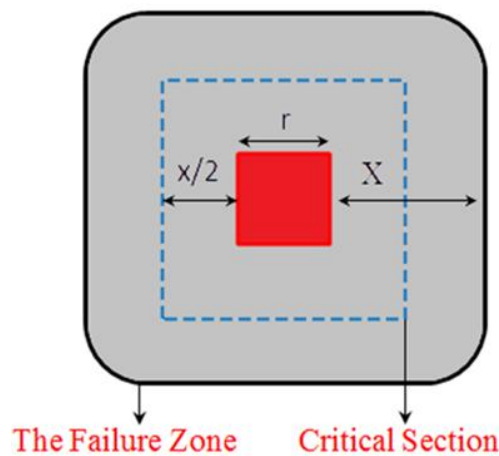
Fig. 19 Calculation of Critical Sections

In accordance with ACI (318-19) [22] and B.S. (8110) [23] the critical section perimeter was assumed to be at (d/2) and (1.5d) from the column face. For the slabs examined in this study, the critical section is defined as half the distance between the end of the failure surface and the column side. The computed distances are based on

the area of failure measured using AutoCAD. The technique for calculating the critical sections for the investigated slabs is shown in Figure (19). Tuan [24] demonstrated that the critical section perimeters for high strength concrete are equal to (2d), which is consistent with (CEB-FIP Model Code-1990) [25]. Table (10) contains the estimated critical section values for each set of slabs tested.

$$\pi x^2 + 4rx + r^2 = A$$

x: distance between the end of the failure zone and the column's side (m).
